# Otter- Hydrology Project: Satpura Tiger Reserve

Project Progress Report

Feb 2022

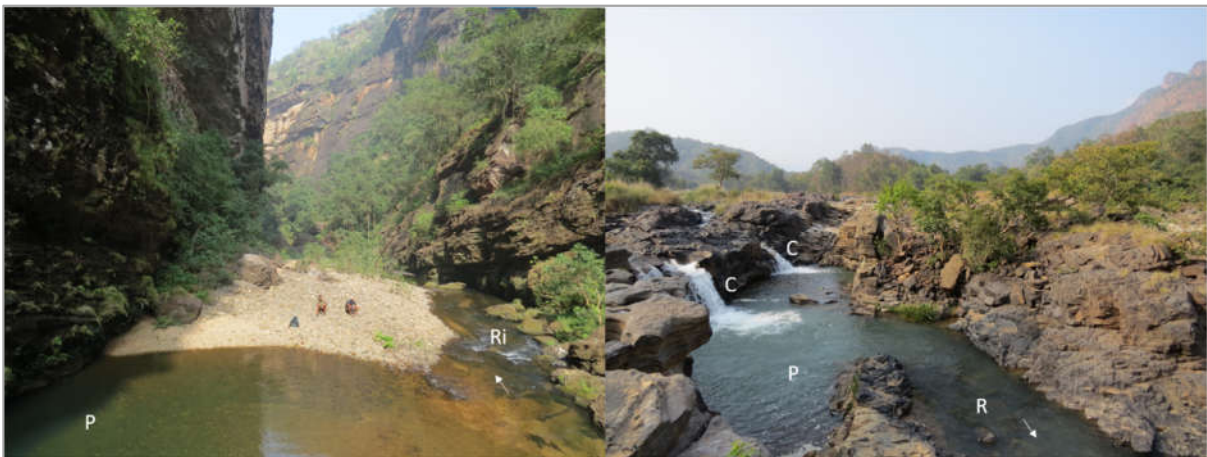
**FIGURE 9 REPRESENTATION OF IN-STREAM HABITAT TYPES – POOL (P), RIFFLE (Ri), CASCADE (C), RUN (R). STREAM HABITATS ARE CLASSIFIED AT DIFFERENT SCALES ACROSS THE STREAM / SEGMENT / POOL-RIFFLE SEQUENCE / MICRO-HABITAT LEVEL**

Additionally, the survey is recording otters signs (spraint, spoor, holt, Figure 8), and assessing stream habitat characteristics such as channel width, pool depth, instream habitat type (pool, riffle, run, cascade), substrate type, presence of pool refugia, cover (vegetation, boulders), and bank slope (Figure 9). Further, prey (fish) availability is being assessed through underwater video recordings (Figure 10) at 51 sampling sites (Figure 11).

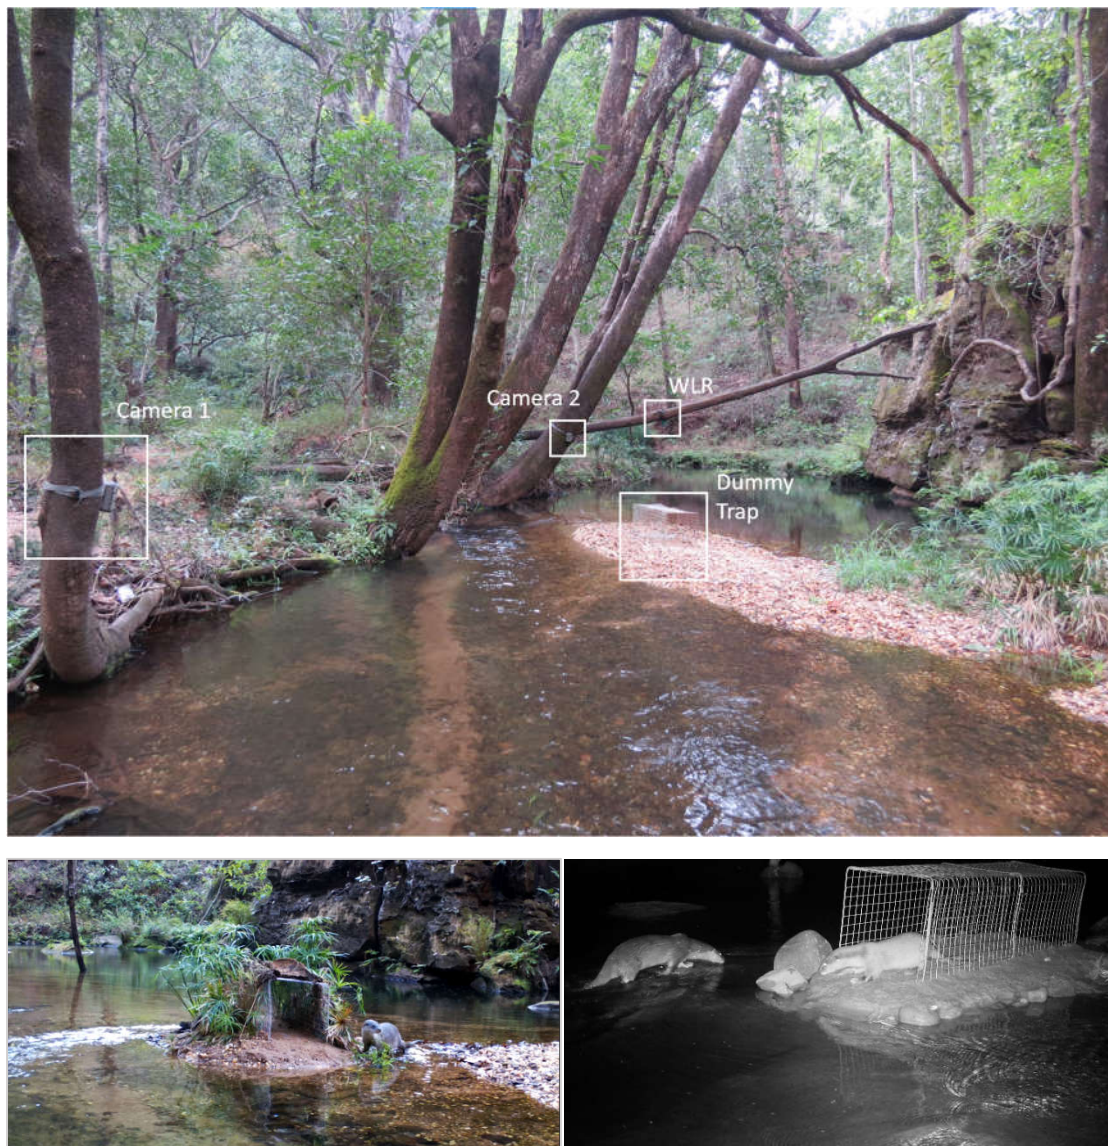
**FIGURE 13 DUMMY TRAP CAGES HAVE BEEN SET UP AT SITES WITH A HIGH FREQUENCY OF OTTER DETECTIONS. THESE ARE POTENTIAL OTTER CAPTURE SITES FOR THE TAGGING AND TELEMETRY COMPONENT OF THE PROJECT AND ARE BEING MONITORED REGULARLY WITH 2-3 CAMERA TRAPS, AND WATER LEVEL RECORDERS (WLR) IN THE VICINITY (SEE TOP). OLFACTORY LURES (FISH-SCENT) ARE OCCASIONALLY PLACED IN THE DUMMY TRAPS TO ATTRACT OTTERS AND GET THEM ACCUSTOMED TO THESE TRAPS PRIOR TO THE DEPLOYMENT OF LIVE TRAPS. OTTERS ARE NOW REGULARLY VISITING AND ENTERING THE DUMMY TRAPS AS SEEN IN THE IMAGES AT THE BOTTOM.**

Equipment and tags were finalized for the project in consultation with the veterinarians and biologists. Traps to safely capture otters were successfully tested in the field for acceptance by wild otters. Video surveillance equipment was developed and installed to monitor the otter traps to tag the animals with minimum handling and stress.

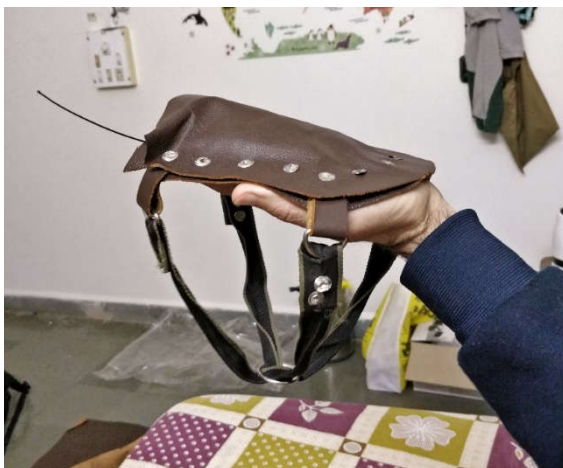
FIGURE 17: RADIO- TAG HARNESS DESIGNED FOR THE

To understand the movement and ecology of otters, preparations for otter telemetry were completed. A specialised telemetry harness to fit the receiver on otters was designed.

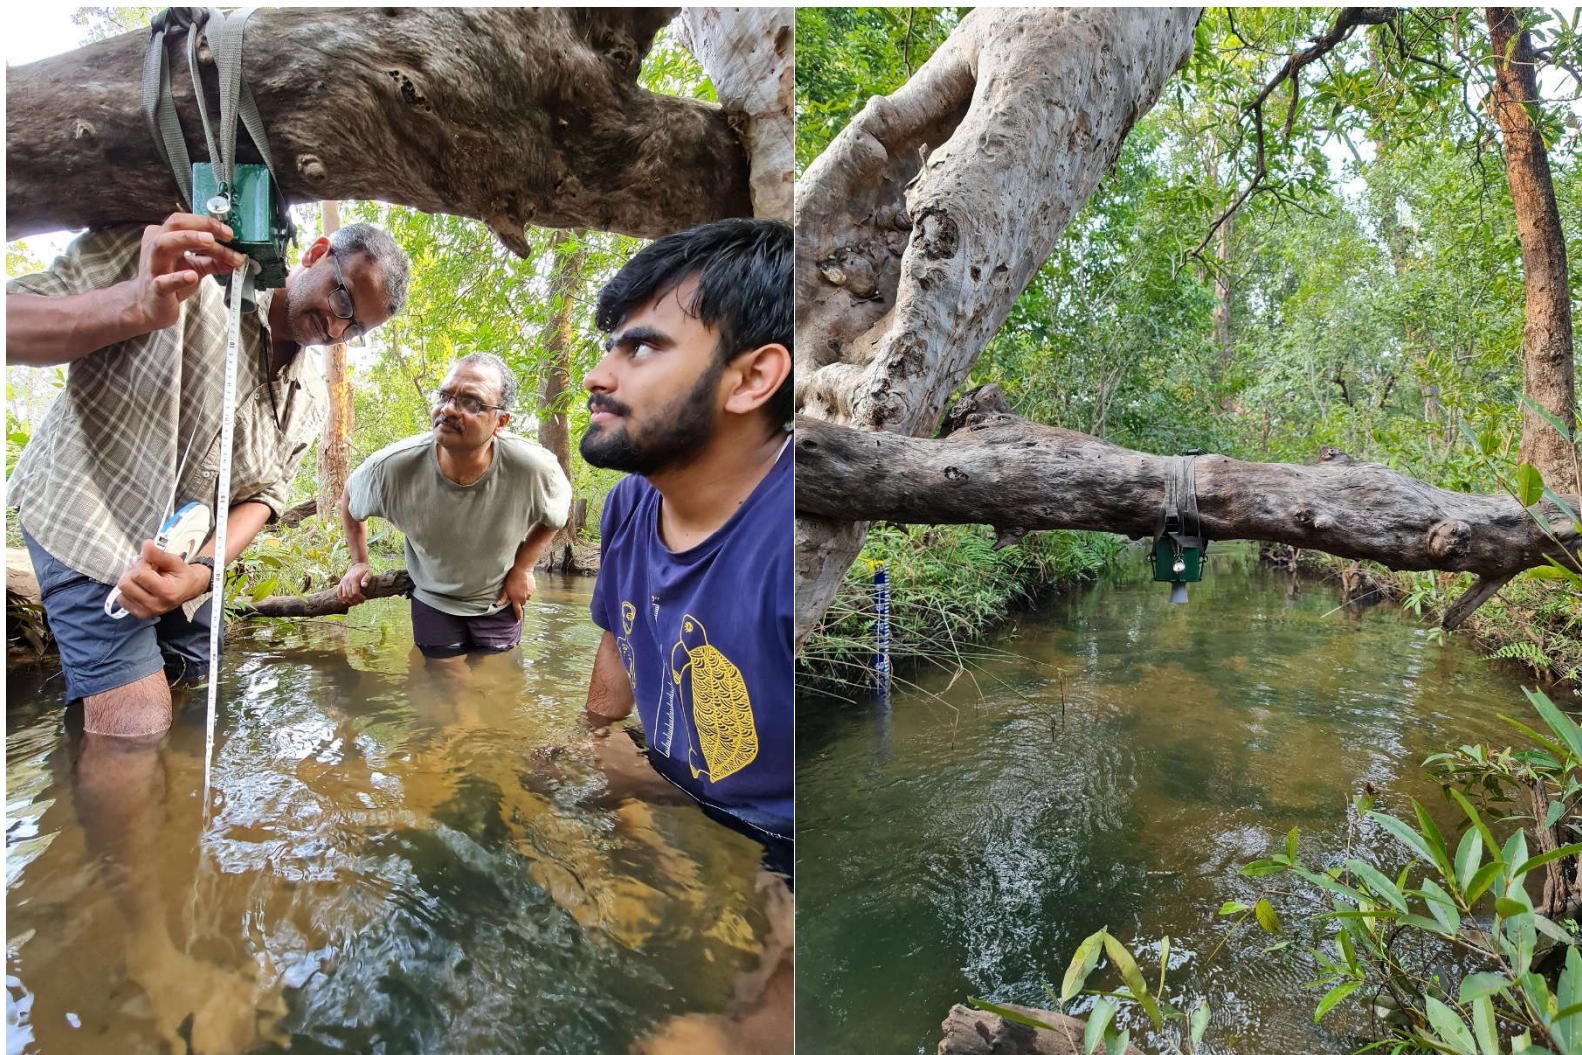
FIGURE 18: FIELD INSTALLATION OF AN ACOUSTIC WATER LEVEL RECORDER (WLR)

We completed the installation of Acoustic Water Level Recorders (WLRs) at multiple sites to measure the changes in water levels in the streams/rivers. At each of these WLR sites, we are manually mapping the stream profile and measuring the water flow velocities, this will also allow us to calculate the volume of flow in the streams.

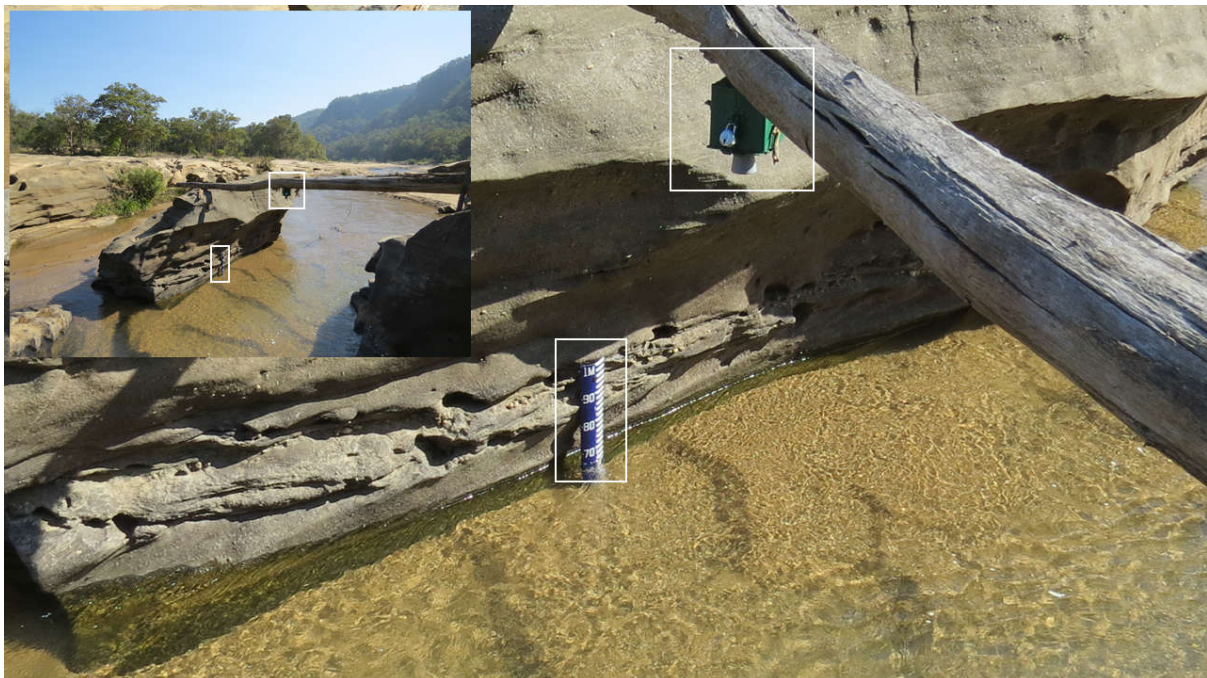
**FIGURE 19 STAFF GAUGE AND WLR INSTALLATION AT DEHLIYA, DENWA RIVER**

The stage is the height of the water surface above an established depth where the level is zero. The zero level is arbitrary and will be close to the bottom of the channel if the river section is shallow. A continuous record of stage is obtained by systematic observation of staff gauges, or with automatic water level recorders (WLR).

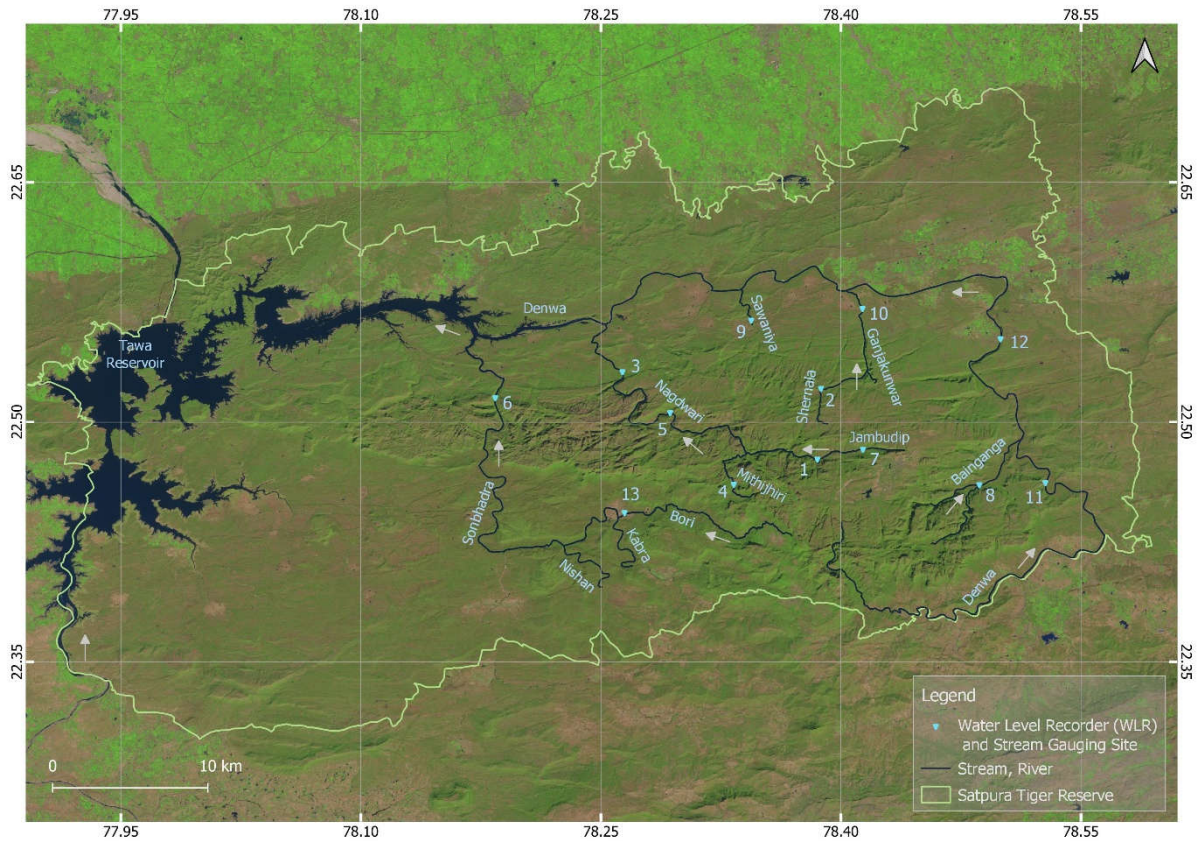
**FIGURE 20 : LOCATIONS OF WATER LEVEL RECORDERS AND STREAM GAUGING SITES IN THE SATPURA TIGER RESERVE**

WLRs and staff gauges have been installed at 13 locations (Figure 3) in the study area within the Denwa River System (including the tributaries Bainganga, Shernala - Ganjakunwar, Sawaniya, Jambudip - Mithijhiri - Nagdwari, and Bori - Sonbhadra). The upper catchments of these stream gauging sites are also being assessed for the installation of rain gauges in the following weeks.

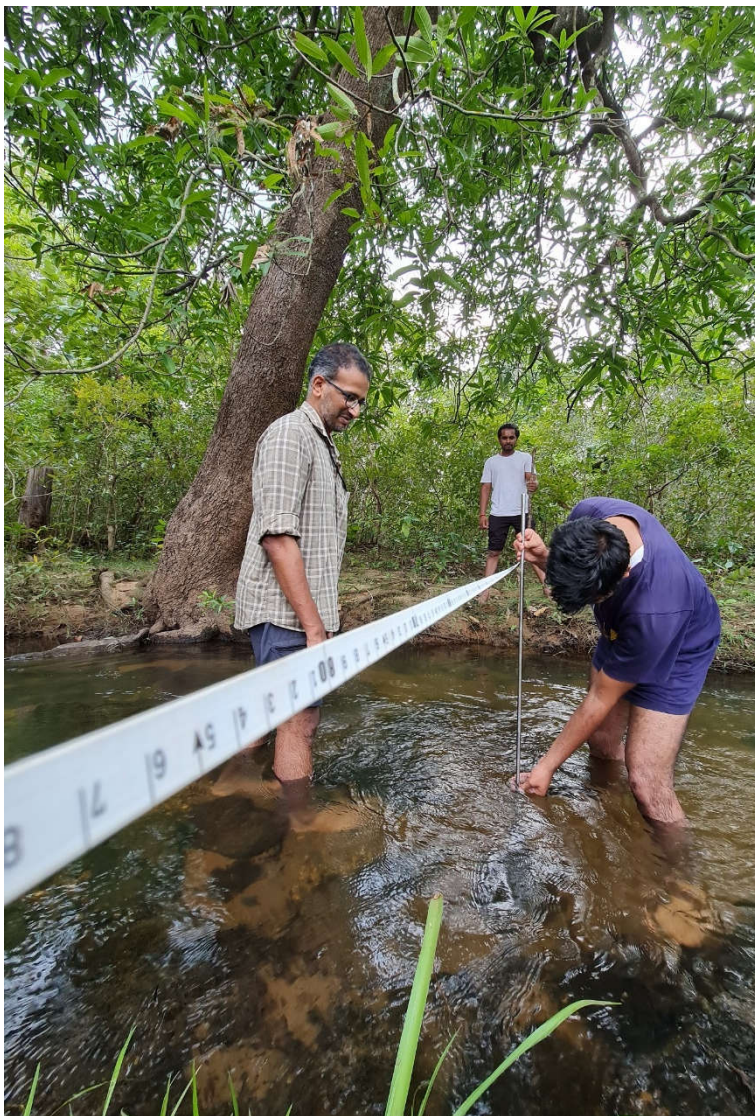
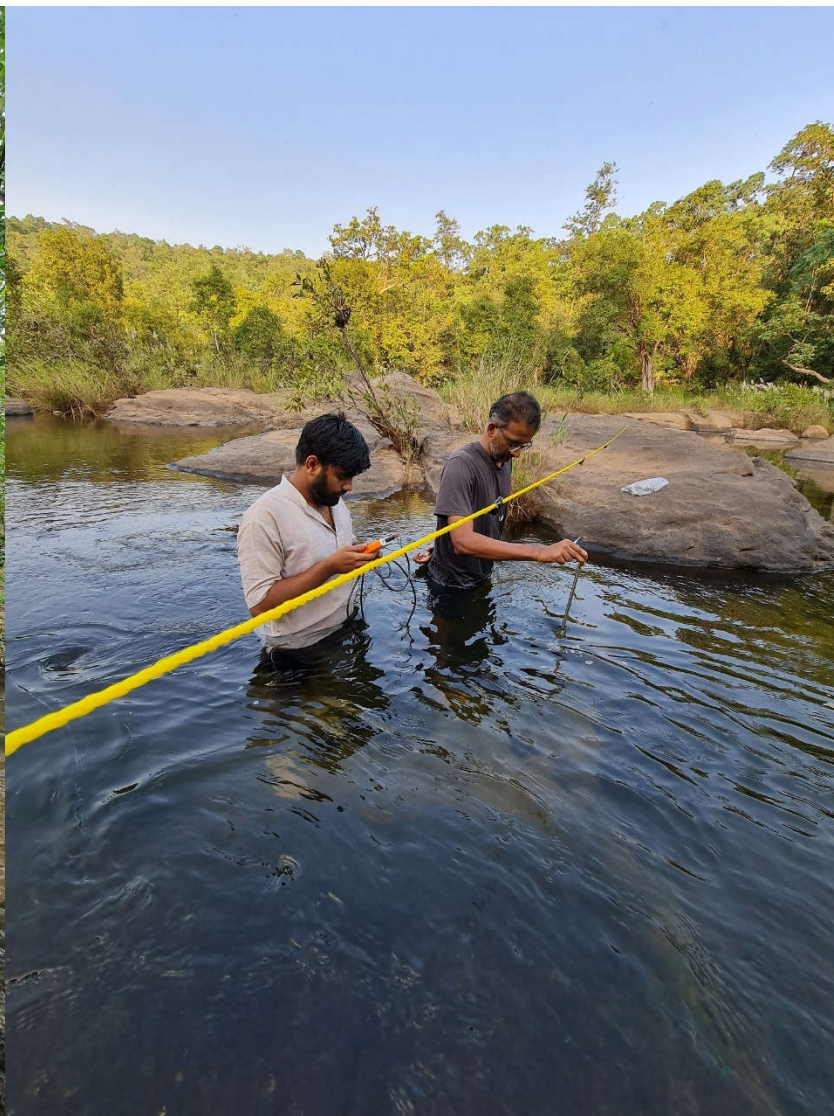
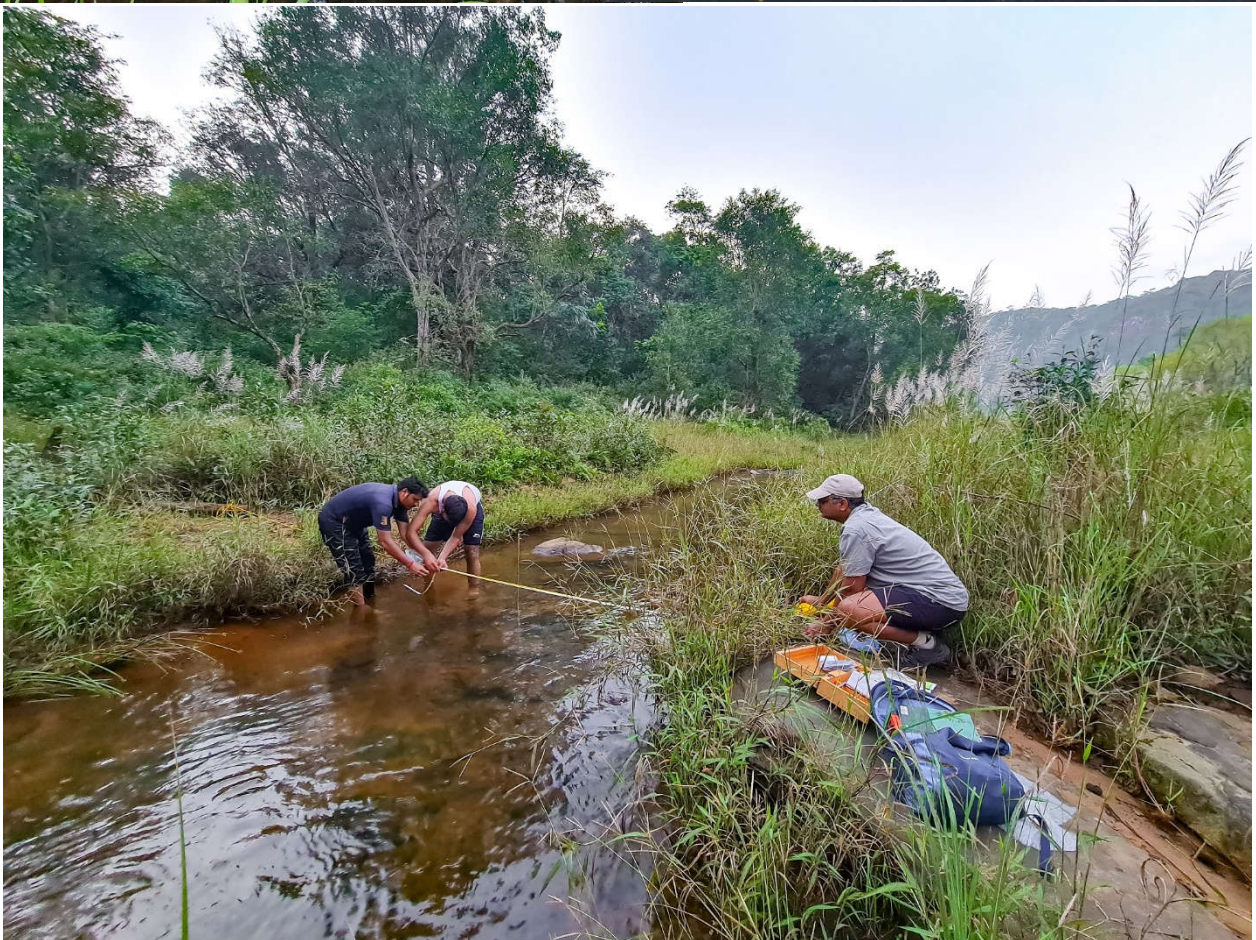
**FIGURE 21 MEASUREMENTS OF STREAM WIDTH, DEPTH AND FLOW VELOCITY. FOREST PATROLLING STAFF OCCASIONALLY PARTICIPATED DURING THESE SURVEYS**

Discharge (flow) is the volumetric rate of flow of water in a stream. Discharge is usually expressed in cubic metres per second (Cumecs or  $m^3/sec$ ). Discharge measurements will be made at periodic intervals to define the stage-discharge relationship or to define any change in the relationship caused by changes in channel geometry and/or channel roughness. Discharge cannot be measured directly, but will be computed from variables that can be measured directly, such as stream width, stream depth and flow velocity. The velocity-area method being used here requires measurement of the stream cross-sectional area and stream velocity. Discharge is then calculated as  $Q = VA$ , where  $Q$  is discharge in  $m^3/sec$  (Cumecs),  $V$  is stream velocity (m/sec), and  $A$  is the cross-sectional area ( $m^2$ ).

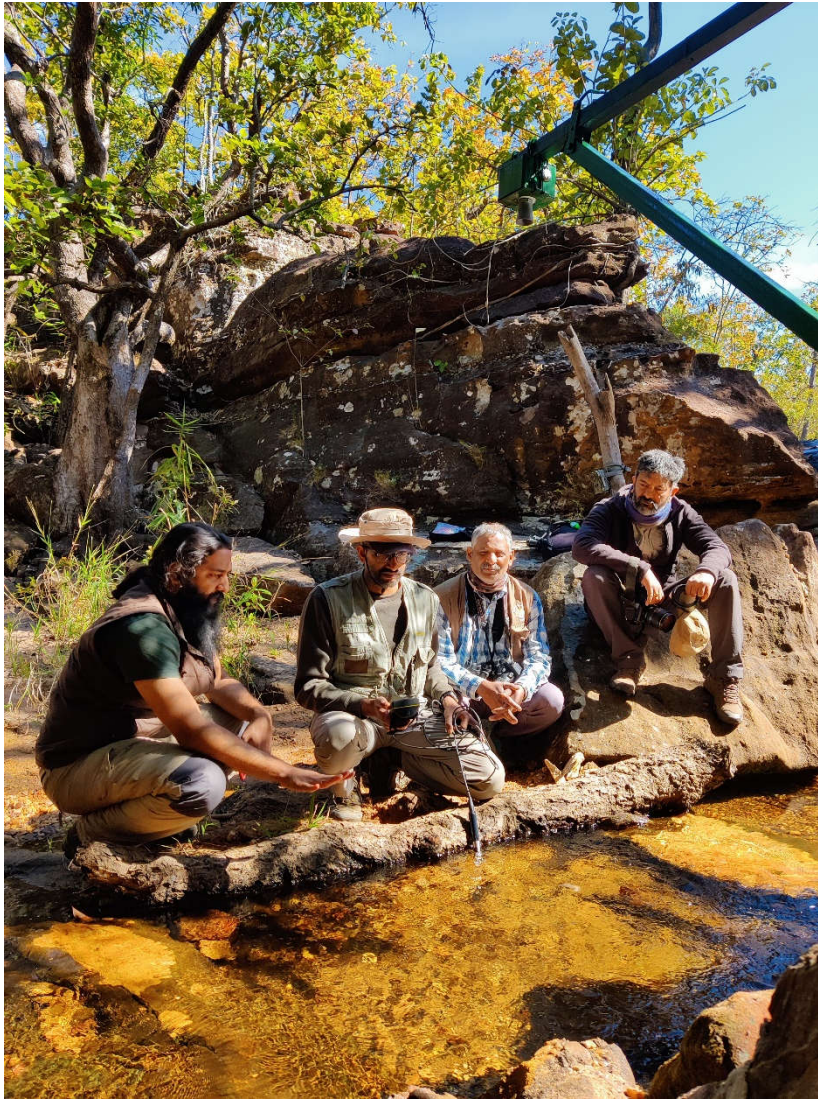
FIGURE 22 COLLECTING DATA ON WATER QUALITY PARAMETERS

In addition, five water quality parameters (Table 2) were recorded from 43 locations during Phase 1 of the otter occupancy and habitat assessment surveys to investigate the influence of water quality on otters and their fish prey.

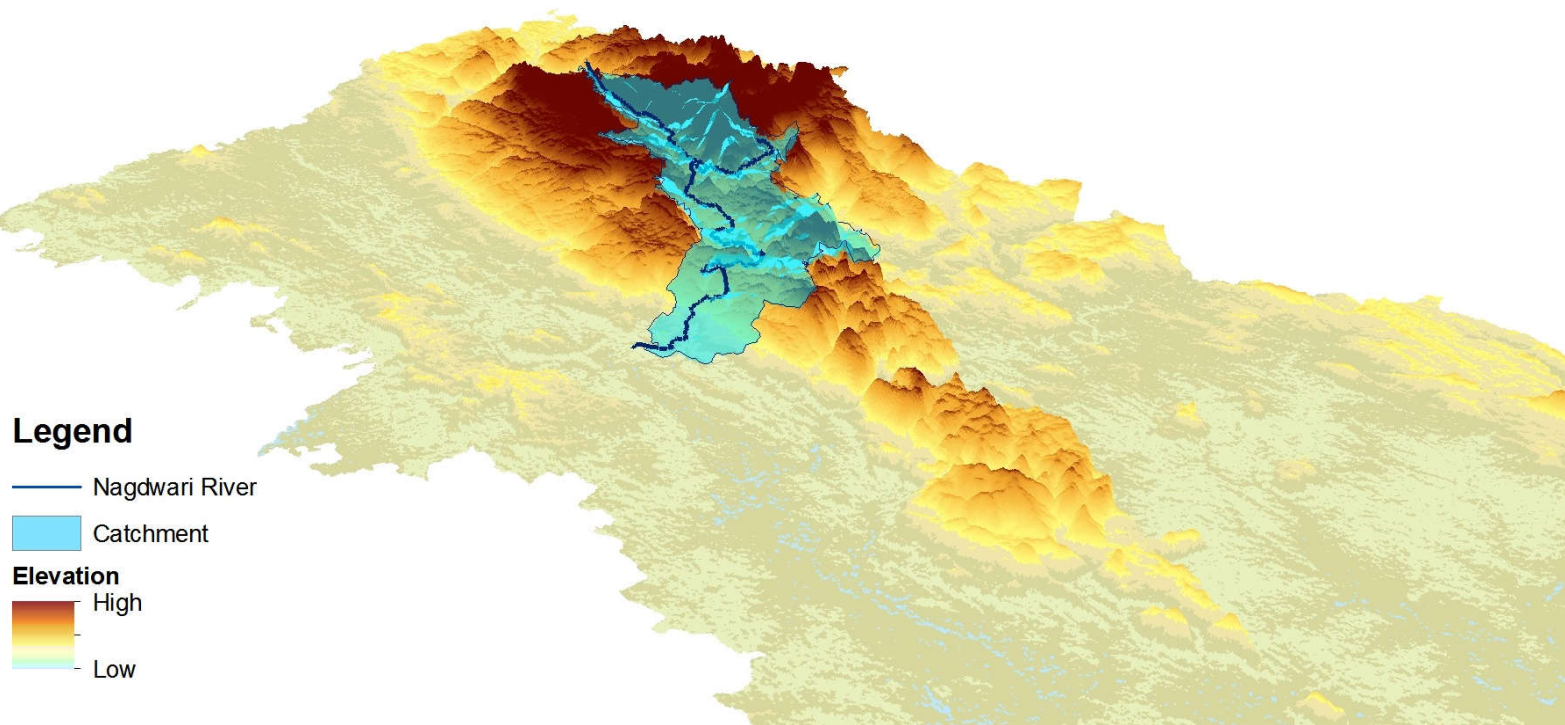
FIGURE 23 MAP SHOWING THE CATCHMENT AREA OF THE NAGDWARI RIVER

Using GIS and Remotely Sensed imageries, we have mapped the water catchment areas for major rivers in the study area. These catchment areas will help us to analyse the hydrology data separately for each catchment along with the otter presence data obtained from areas within respective catchments.

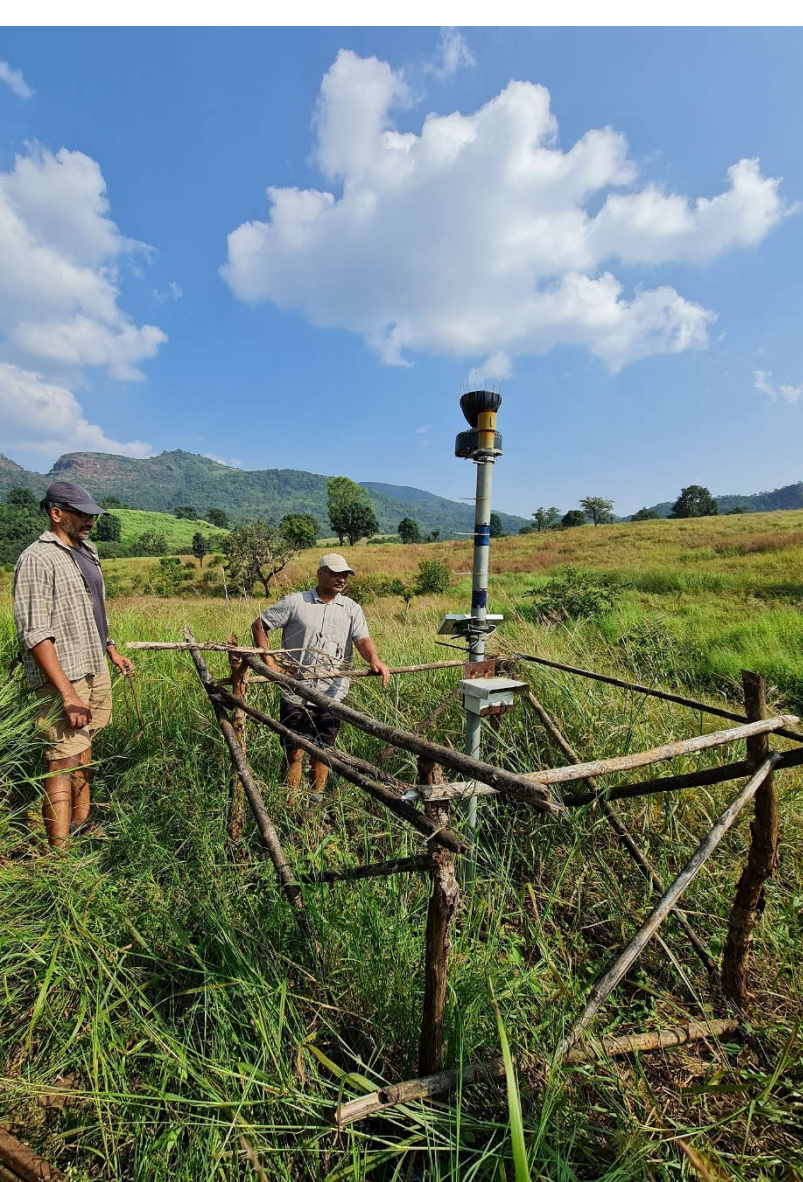
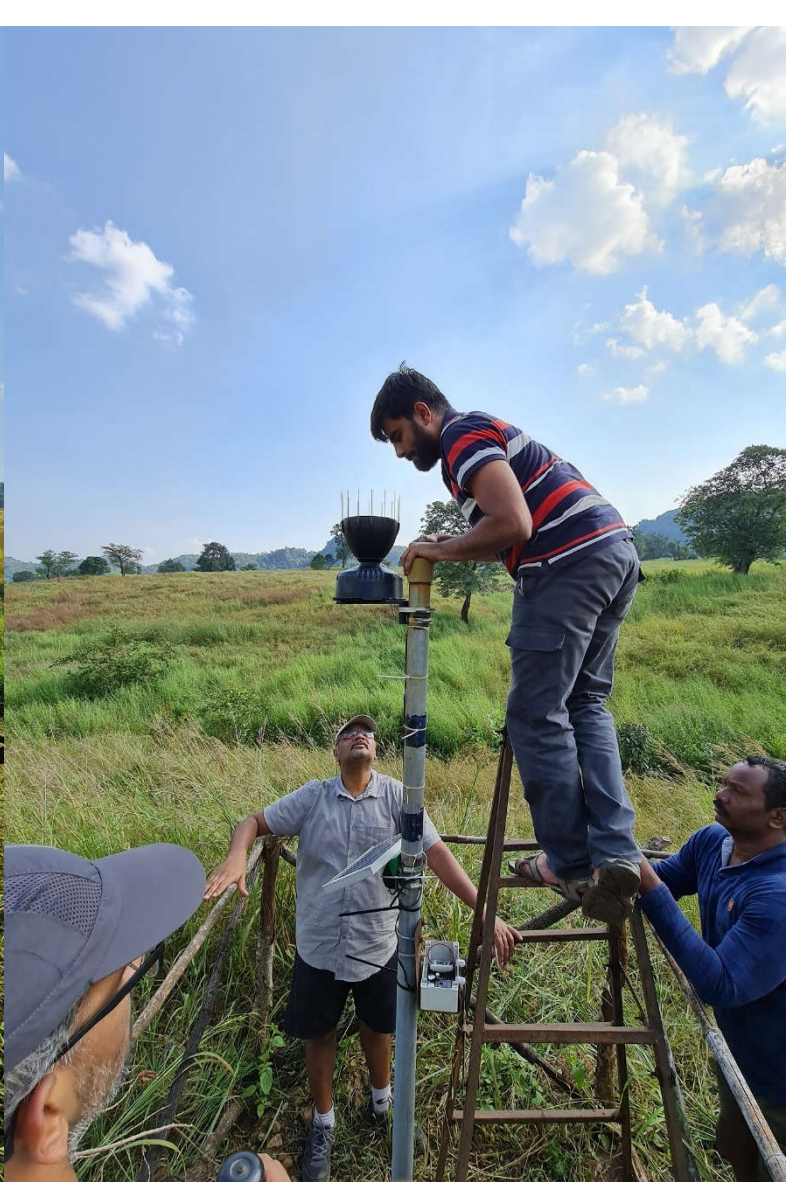
**FIGURE 24: INSTALLATION OF RAIN-GAUGES IN THE FIELD**

We have also placed rain gauges within each river catchment to precisely collect the rainfall data and correlate it with water flow. This will provide information on how much water translates into surface flows and it will also throw light on the hydrologic characteristic of the catchment.
